POINT HOPE AIRPORT

2004 Alaska Airport Pavement Condition Report

POINT HOPE AIRPORT - 2004

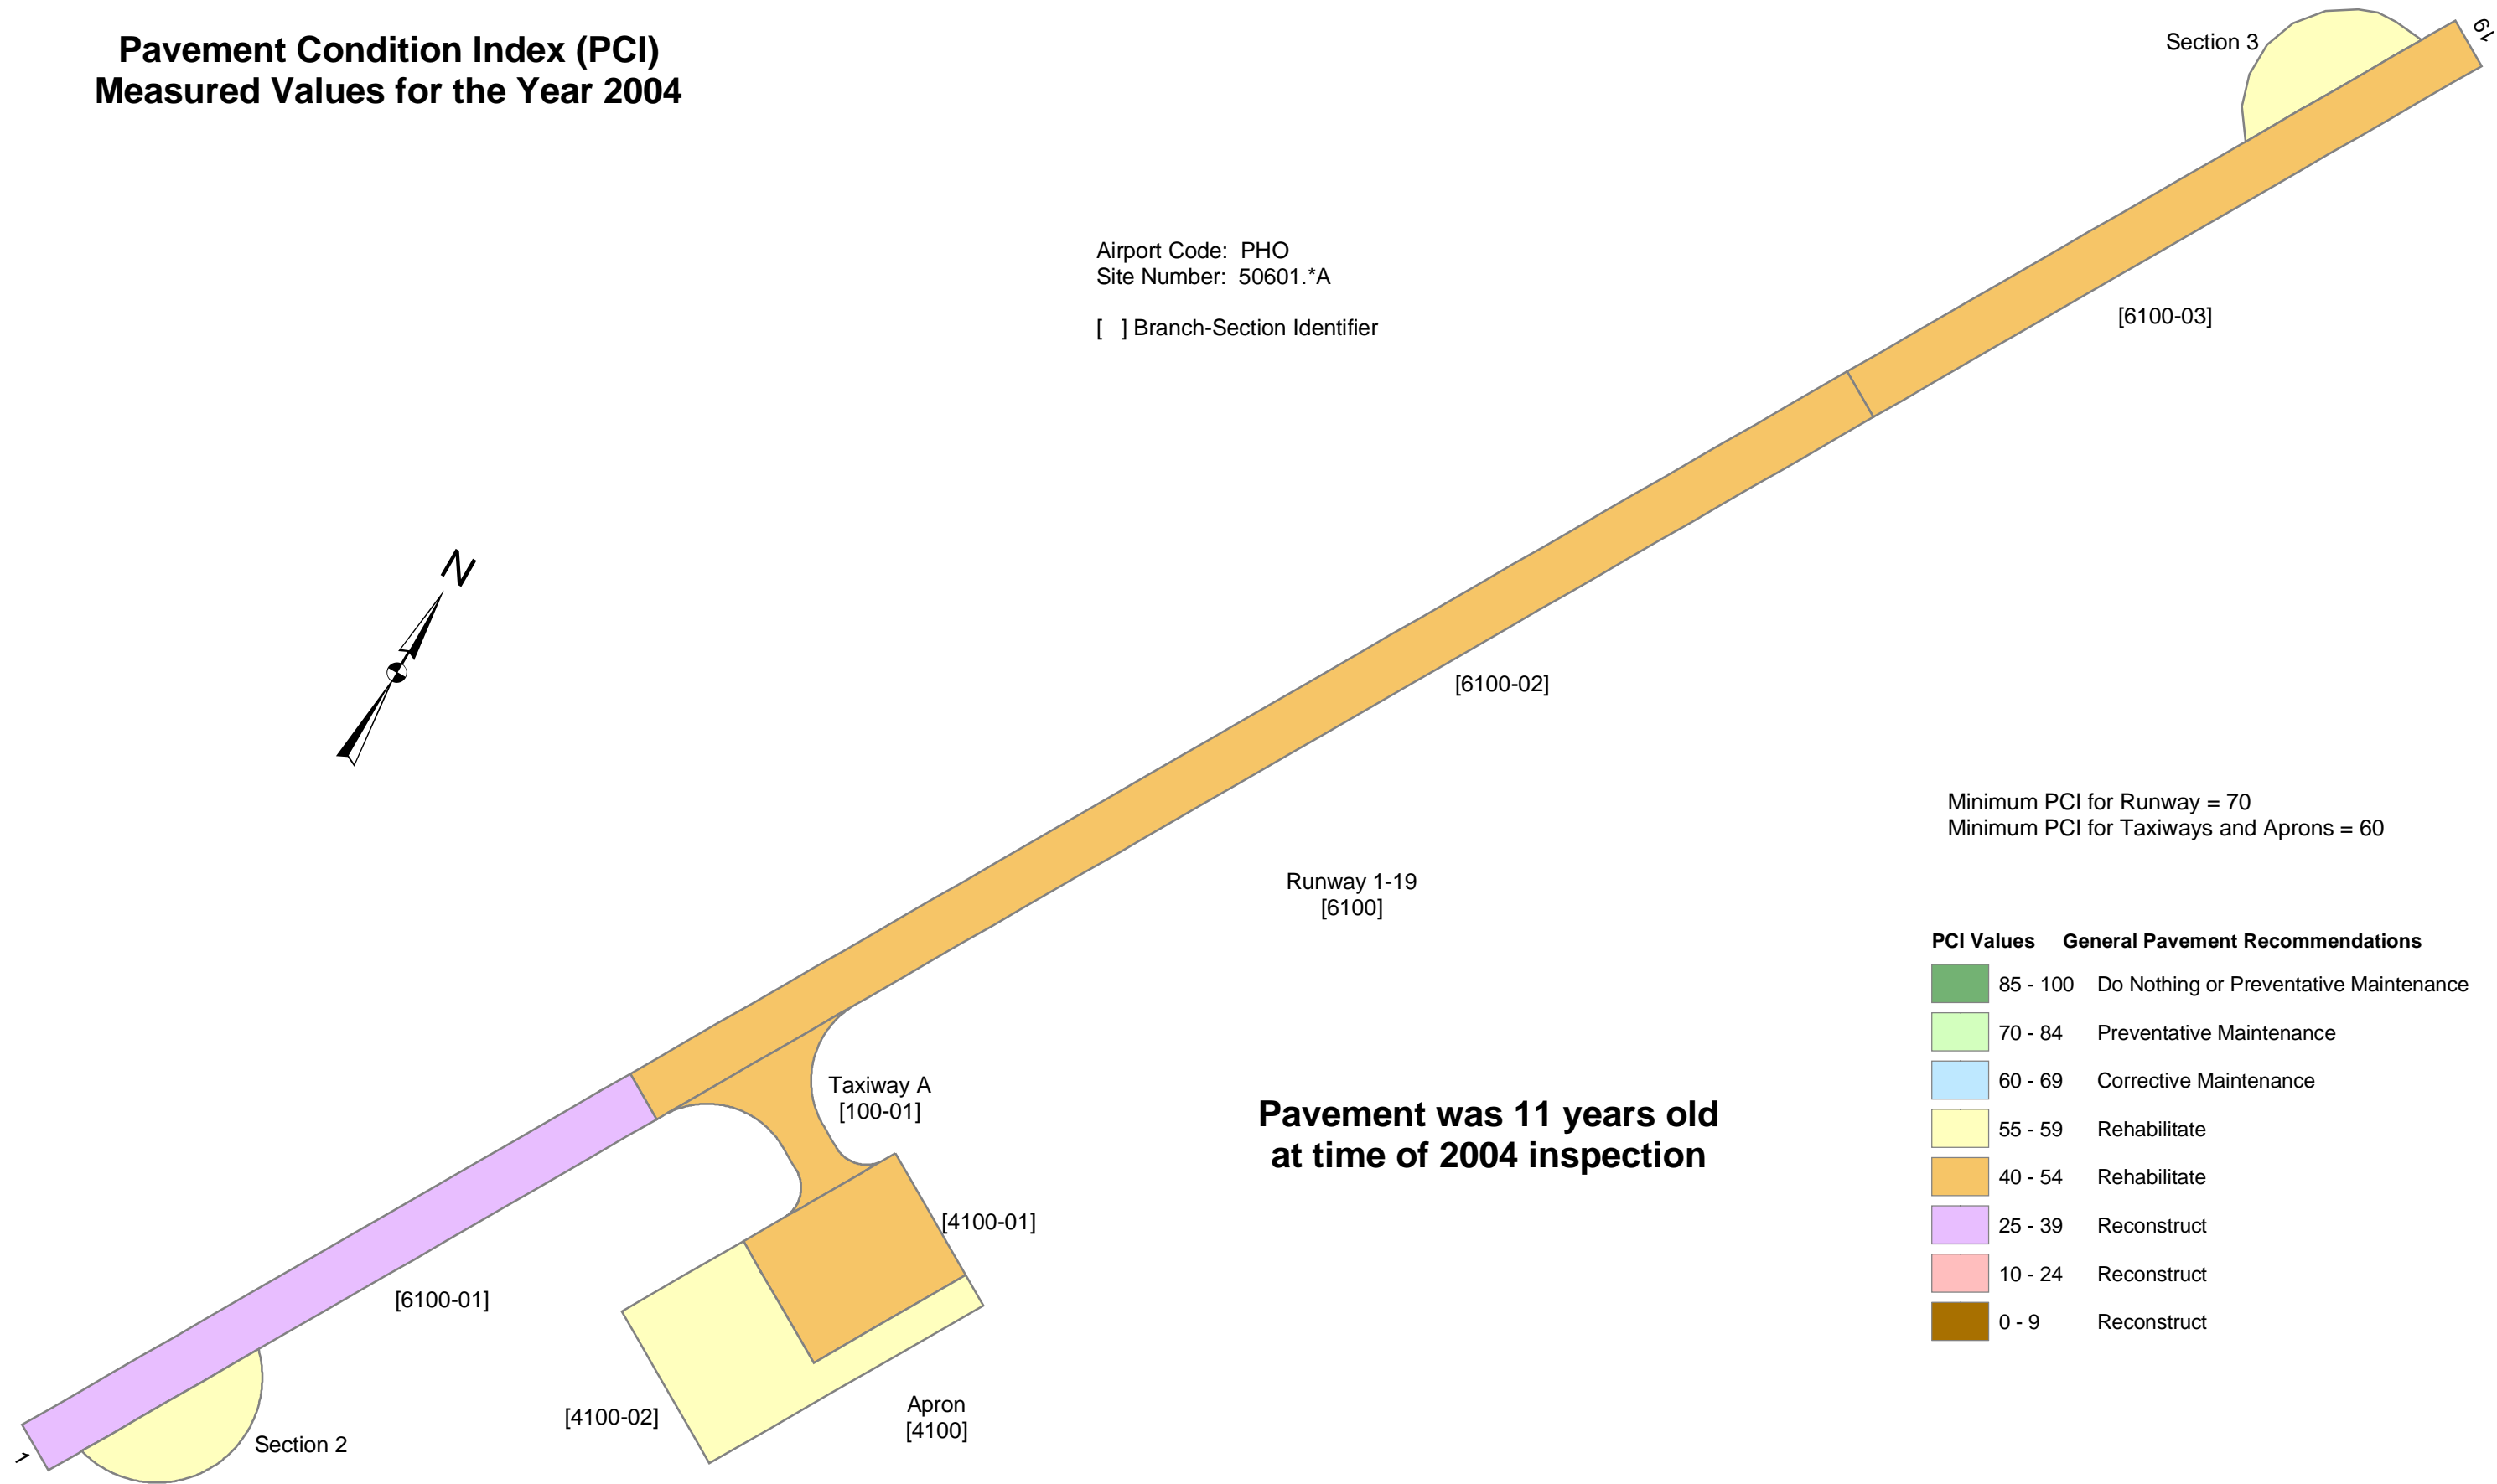
Pavement Condition Index (PCI)
Measured Values for the Year 2004

Pavement was 11 years old
at time of 2004 inspection
